**Flood Control Project Maintenance
Levee Inspections**

Maintenance Issue Types Only, Levee Inspection Report By Mile - Spring 2017

Lake County Watershed Protection District

Waterway	Bank	Unit Miles	Inspection Start/End	Inspector
Unit No. 01 Middle Creek	Left	3.35	04/04/2017 04/04/2017	Bob Duffey

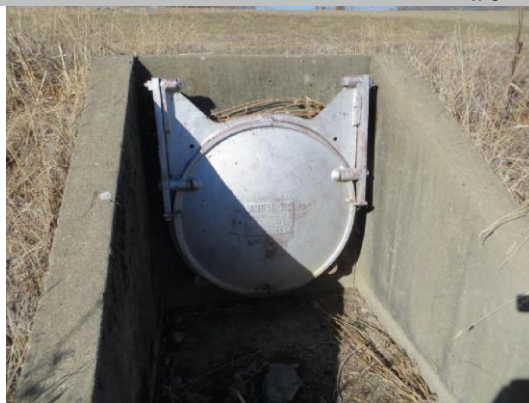
Photo 3 of 3 : UCIP_SP_2017_27004_49860.jpg

LM Start	2.35	Rating **	M	Issue No.	539 (cont)
LM End	2.35	Issue Type +	Ma	Location *	WS

Concrete U-shaped headwall and flap gate on WS berm.

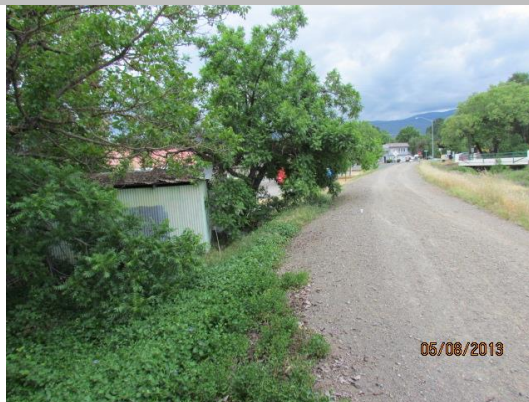
Photo 1 of 1 : SP_2017_NA0009_3_15_20170315_00009.jpg

LM Start	2.38	Rating **	M	Issue No.	15
LM End	2.41	Issue Type +	Ma	Location *	LS
Category	Earthen Levee			GPS Latitude/Longitude	
				Start	End
Item	Trim / Thin Trees			39.161381 °	39.161708 °
				-122.912551 °	-122.912168 °
DWR ID	DWR_NA0009_01_s_2013_15				
Comment Code					
T1 : Trim trees to at least five feet above ground level.					
Inspector Comment

Trim the trees up 5 feet to allow visibility.

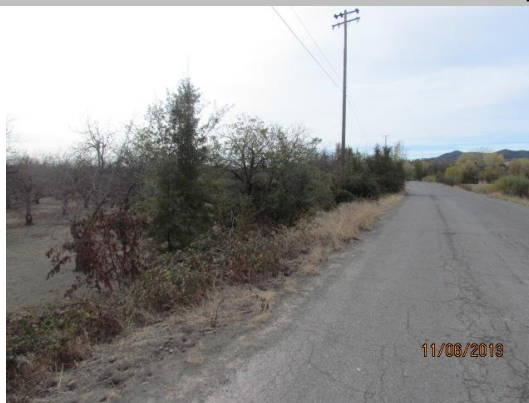
Photo 1 of 2 : SP_2017_NA0009_3_3_20170315_00001.jpg

LM Start	2.48	Rating **	U	Issue No.	3
LM End	2.55	Issue Type +	Ma	Location *	LS
Category	Earthen Levee			GPS Latitude/Longitude	
				Start	End
Item	Vegetation			39.161615 °	39.160804 °
				-122.911733 °	-122.912536 °
DWR ID	DWR_NA0009_01_s_2012_3				
Comment Code					
V2 : Remove the wild growth other than native grasses from the levee slopes.					
Inspector Comment

View of the vegetation along the landside slope.

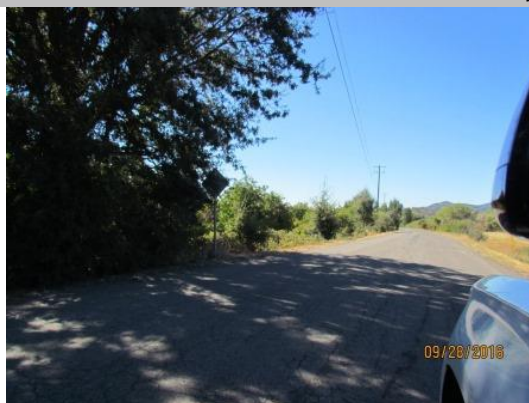
Photo 2 of 2 : SP_2017_NA0009_3_3_20170315_00002.jpg

LM Start	2.48	Rating **	U	Issue No.	3 (cont)
LM End	2.55	Issue Type +	Ma	Location *	LS

View of the vegetation along the landside slope.

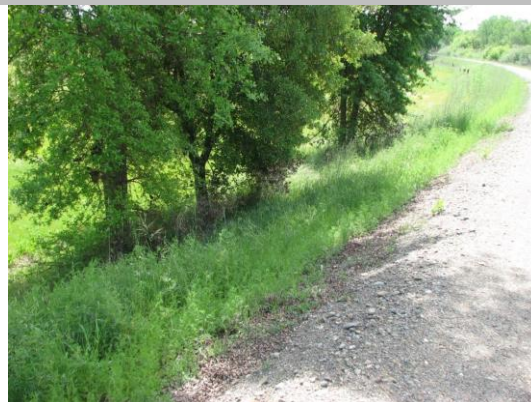
Photo 1 of 1 : SP_2017_NA0009_3_25_20170315_00015.jpg

LM Start	2.95	Rating **	M	Issue No.	25
LM End	2.95	Issue Type +	Ma	Location *	LS
Category	Earthen Levee			GPS Latitude/Longitude	
				Start	End
Item	Trim / Thin Trees			39.155301 °	39.155301 °
				-122.914633 °	-122.914633 °
DWR ID	DWR_NA0009_01_s_2016_25				
Comment Code					
T1 : Trim trees to at least five feet above ground level.					
Inspector Comment

Trim trees to 5' above levee slope (LS). 4/19/2016

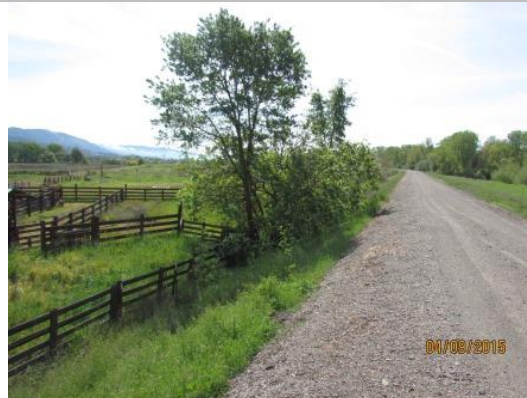
Photo 1 of 1 : SP_2017_NA0009_3_534_20170315_00021.jpg

LM Start	3.26	Rating **	M	Issue No.	534
LM End	3.26	Issue Type +	Ma	Location *	LS
Category	Earthen Levee			GPS Latitude/Longitude	
				Start	End
Item	Trim / Thin Trees			39.150957 °	39.150957 °
				-122.913504 °	-122.913504 °
DWR ID	DWR_NA0009_01_s _ 2015_534				
Comment Code					
T2 : Thin trees to allow visibility of the ground and room to flood fight.					
Inspector Comment

Remove the trees from the landside toe.

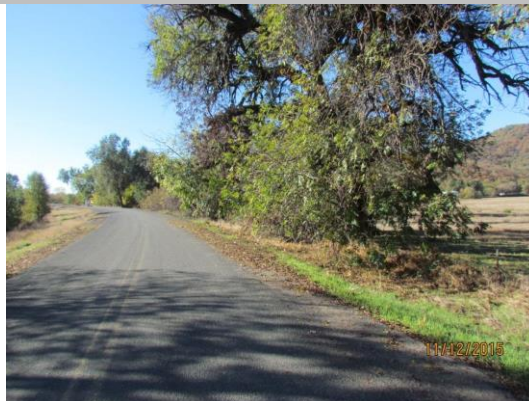
Photo 1 of 1 : SP_2017_NA0009_4_4_20170315_00004.jpg

LM Start	0.02	Rating **	M	Issue No.	4
LM End	0.14	Issue Type +	Ma	Location *	LS
Category	Earthen Levee			GPS Latitude/Longitude	
				Start	End
Item	Trim / Thin Trees			39.189540 °	39.187900 °
				-122.908065 °	-122.908655 °
DWR ID	DWR_NA0009_02_s_2013_4				
Comment Code					
T1 : Trim trees to at least five feet above ground level.					
Inspector Comment					
Trim the trees up 5 feet to allow visibility.

View of the overgrown trees at the landside toe.

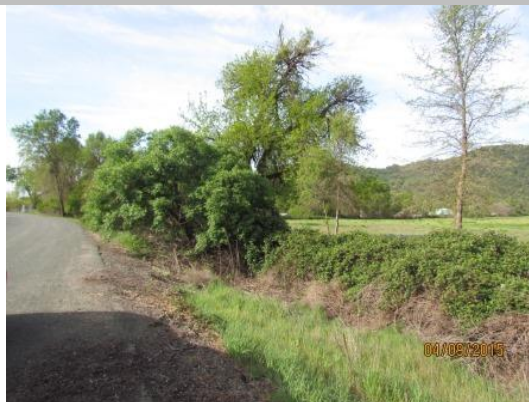
Photo 1 of 1 : SP_2017_NA0009_4_19_20170315_00010.jpg

LM Start	0.08	Rating **	M	Issue No.	19
LM End	0.08	Issue Type +	Ma	Location *	LS
Category	Earthen Levee			GPS Latitude/Longitude	
				Start	End
Item	Vegetation			39.188772 °	39.188772 °
				-122.908465 °	-122.908465 °
DWR ID	DWR_NA0009_02_s_2014_19				
Comment Code					
V4 : Elderberries are blocking visibility and flood fight capability.					
Inspector Comment

View of the elderberries along the landside toe.

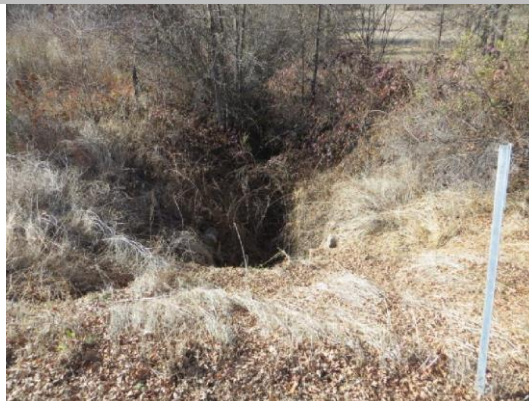
Photo 1 of 3 : UCIP_SP_2017_27066_50049.jpg

LM Start	0.14	Rating **	A/W	Issue No.	32
LM End	0.14	Issue Type +	Ma	Location *	LS
Category	Supplemental			GPS Latitude/Longitude	
				Start	End
Item	DWR UCIP LMA Responsibility			39.187919 °	39.187919 °
				-122.908631 °	-122.908631 °
DWR ID					
Comment Code					
Inspector Comment					
FS_ID:27066 DS_ID:21201 EP_NO: 11485 Repair Type: No Action Needed Crossing Status: Found UCIP Comments: FIELD_STRUCT_DESC: 42-inch CM drainpipe through the levee, 8.5 feet below the crown. Flap gate on the waterward side. Concrete headwalls on both ends. Originally included in 1961 O+M manual. This pipe was retained under ABO No. 11485 (1975). FS Date: 1/14/2014

Pipe and headwall visible at LS toe in drainage swale.

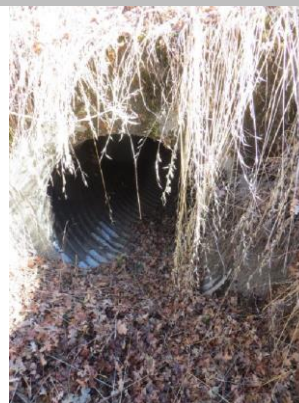
Photo 2 of 3 : UCIP_SP_2017_27066_50048.jpg

LM Start	0.14	Rating **	A/W	Issue No.	32 (cont)
LM End	0.14	Issue Type +	Ma	Location *	LS

Pipe and headwall visible at LS toe in drainage swale.

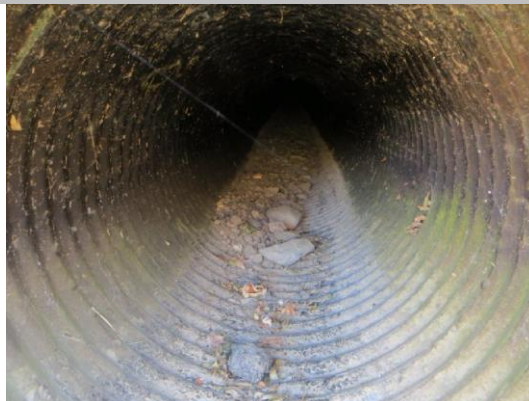
Photo 2 of 3 : UCIP_SP_2017_27184_50321.jpg

LM Start	0.24	Rating **	A/W	Issue No.	33 (cont)	
LM End	0.24	Issue Type +	Ma	Location *	LS	
Category	Supplemental			GPS Latitude/Longitude		
				Start		End
Item	DWR UCIP LMA Responsibility			39.186794 °		39.186794 °
				-122.909413 °		-122.909413 °
DWR ID						
Comment Code						
Inspector Comment						
FS_ID:27184 DS_ID:21204 EP_NO: 11484 Repair Type: No Action Needed Crossing Status: Found UCIP Comments: FIELD_STRUCT_DESC: 36-inch CM drainpipe through the levee, 6 feet below the crown. Flap gate on the waterward end. Concrete headwalls on both ends. Originally included in 1961 O+M manual. This pipe was retained under ABO No. 11484 (1975). FS Date: 1/14/2014

Pipe at inlet.

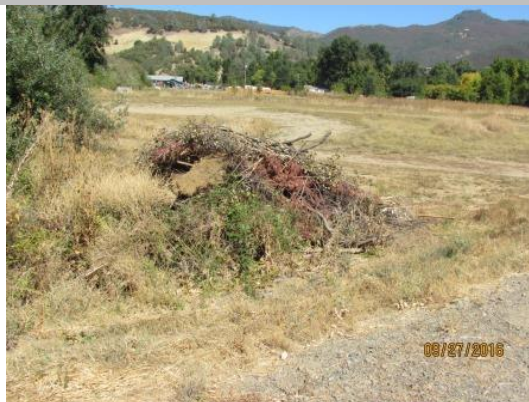
Photo 1 of 1 : SP_2017_NA0009_4_17_20170315_00008.jpg

LM Start	0.38	Rating **	M	Issue No.	17
LM End	0.38	Issue Type +	Ma	Location *	LS
Category	Earthen Levee			GPS Latitude/Longitude	
				Start	End
Item	Encroachments			39.185239 °	39.185239 °
				-122.911018 °	-122.911018 °
DWR ID	DWR_NA0009_02_f _ 2016_17				
Comment Code					
PR : Prunings					
Inspector Comment

View of the prunings along the landside toe.

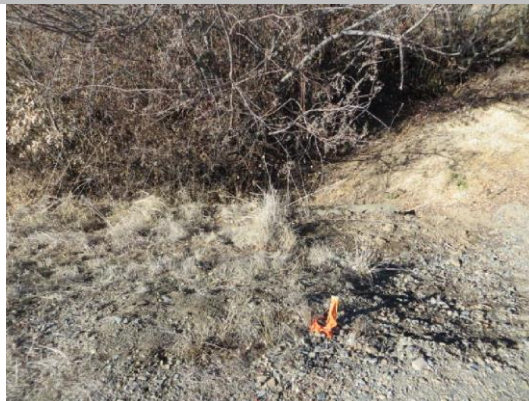
Photo 1 of 3 : UCIP_SP_2017_27192_50326.jpg

LM Start	0.39	Rating **	A/W	Issue No.	34
LM End	0.39	Issue Type +	Ma	Location *	LS
Category	Supplemental			GPS Latitude/Longitude	
				Start	End
Item	DWR UCIP LMA Responsibility			39.185174 °	39.185174 °
				-122.911171 °	-122.911171 °
DWR ID					
Comment Code					
Inspector Comment					
FS_ID:27192 DS_ID:21206 EP_NO: 11478 Repair Type: No Action Needed Crossing Status: Found UCIP Comments: FIELD_STRUCT_DESC: 42-inch CM drainpipe through the levee, 7.7 feet below the crown. Flap gate on the waterward end. Concrete headwalls on both ends. Grouted spillway over revetment on bank. (USACE-1961). This entry matches the Drainage or Irrigation Structure referenced in O&M manual (HLM 0.38). This pipe was retained under ABO No. 11478 (1975). FS Date: 1/14/2014

Pipe and concrete headwall at LS toe.

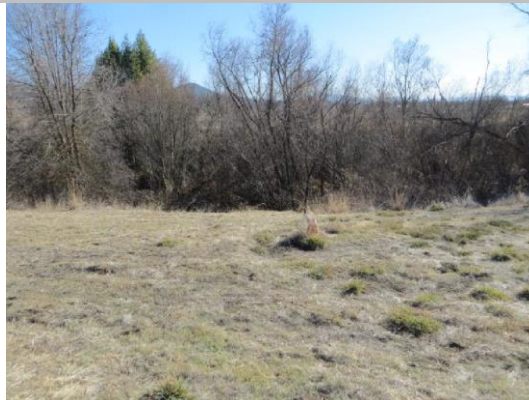
Photo 2 of 3 : UCIP_SP_2017_27192_50325.jpg

LM Start	0.39	Rating **	A/W	Issue No.	34 (cont)
LM End	0.39	Issue Type +	Ma	Location *	LS

Flapgate and headwall off WS toe at berms edge.

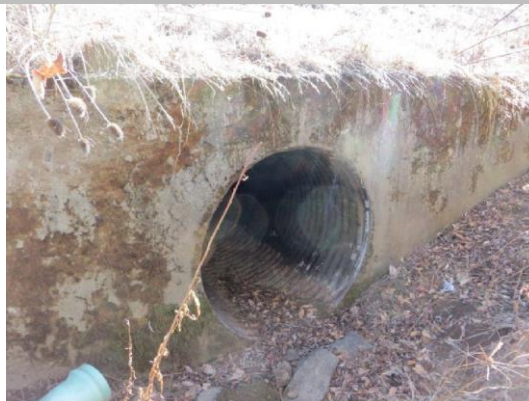
Photo 3 of 3 : UCIP_SP_2017_27192_50324.jpg

LM Start	0.39	Rating **	A/W	Issue No.	34 (cont)
LM End	0.39	Issue Type +	Ma	Location *	LS
Category	Supplemental			GPS Latitude/Longitude	
				Start	End
Item	DWR UCIP LMA Responsibility			39.185174 °	39.185174 °
				-122.911171 °	-122.911171 °
DWR ID					
Comment Code					
Inspector Comment					
FS_ID:27192 DS_ID:21206 EP_NO: 11478 Repair Type: No Action Needed Crossing Status: Found UCIP Comments: FIELD_STRUCT_DESC: 42-inch CM drainpipe through the levee, 7.7 feet below the crown. Flap gate on the waterward end. Concrete headwalls on both ends. Grouted spillway over revetment on bank. (USACE-1961). This entry matches the Drainage or Irrigation Structure referenced in O&M manual (HLM 0.38). This pipe was retained under ABO No. 11478 (1975). FS Date: 1/14/2014

Pipe and concrete headwall at LS toe.

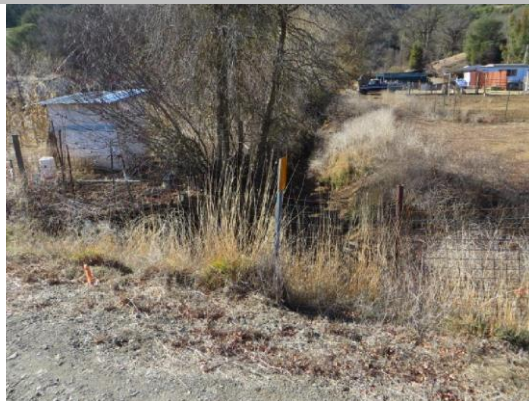
Photo 2 of 3 : UCIP_SP_2017_27199_50388.jpg

LM Start	0.48	Rating **	A/W	Issue No.	35 (cont)	
LM End	0.48	Issue Type +	Ma	Location *	LS	
Category	Supplemental			GPS Latitude/Longitude		
				Start	End	
Item	DWR UCIP LMA Responsibility			39.184126°	39.184126°	
				-122.912118°	-122.912118°	
DWR ID						
Comment Code						
Inspector Comment						
FS_ID:27199						
DS_ID:21208						
EP_NO: 11480						
Repair Type: No Action Needed						
Crossing Status: Found						
UCIP Comments:						
FIELD_STRUCT_DESC: 42-inch CM drainpipe through the levee, 7.0						
feet below the crown. Flap gate on the waterward end. Concrete						
headwalls on both ends. (USACE-1961). This entry matches the						
Drainage or Irrigation Structure referenced in O&M manual (HLM 0.47).						
This pipe was retained under ABO No. 11480 (1975).						
FS Date: 1/14/2014

Pipe and concrete headwall on LS toe.

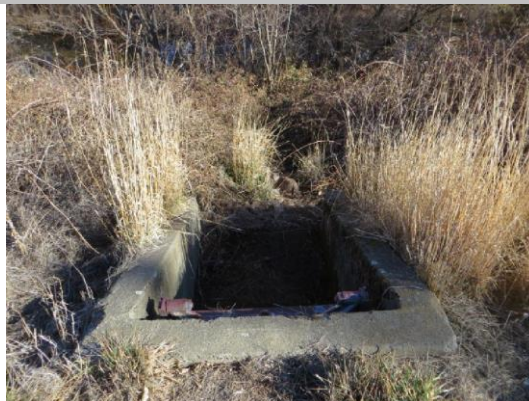
Photo 2 of 3 : UCIP_SP_2017_27208_50410.jpg

LM Start	0.55	Rating **	M	Issue No.	38 (cont)
LM End	0.55	Issue Type +	Ma	Location *	LS
Category	Supplemental			GPS Latitude/Longitude	
				Start	End
Item	DWR UCIP LMA Responsibility			39.183130 °	39.183130 °
				-122.912198 °	-122.912198 °
DWR ID					
Comment Code					
Inspector Comment					
FS_ID:27208 DS_ID:21210 EP_NO: 11482 Repair Type: Non-Urgent Crossing Status: Found UCIP Comments: Fence on LS slope creates access issue. FIELD_STRUCT_DESC: 36-inch CM drainpipe through the levee, 9.0 feet below the crown. Flap gate on the waterward end. Concrete headwalls on both ends. (USACE-1961). This entry matches the Drainage or Irrigation Structure referenced in O&M manual (HLM 0.54). This pipe was retained under ABO No. 11482 (1975). FS Date: 1/14/2014

Flapgate and concrete headwall on WS berm.

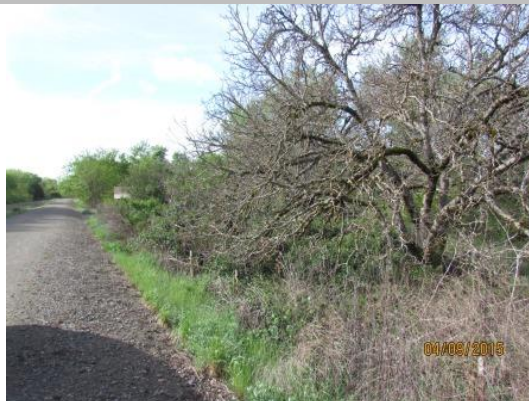
Photo 1 of 1 : SP_2017_NA0009_4_7_20170315_00005.jpg

LM Start	0.97	Rating **	M	Issue No.	7
LM End	0.98	Issue Type +	Ma	Location *	LS
Category	Earthen Levee			GPS Latitude/Longitude	
				Start	End
Item	Vegetation			39.177218 °	39.176992 °
				-122.913673 °	-122.913642 °
DWR ID	DWR_NA0009_02_s_2012_7				
Comment Code					
V2 : Remove the wild growth other than native grasses from the levee slopes.					
Inspector Comment

View of the vegetation at the landside toe.

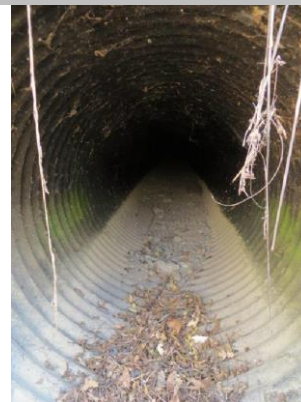
Photo 2 of 3 : UCIP_SP_2017_27583_51201.jpg

LM Start	1.03	Rating **	A/W	Issue No.	39 (cont)
LM End	1.03	Issue Type +	Ma	Location *	WS

Pipe as visible from LS toe.

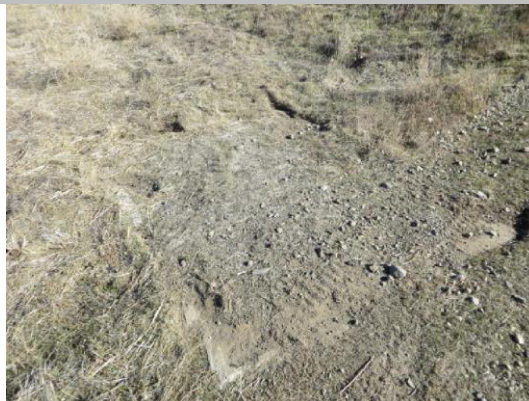
Photo 2 of 3 : UCIP_SP_2017_42994_51213.jpg

LM Start	1.16	Rating **	M	Issue No.	40 (cont)
LM End	1.16	Issue Type +	Ma	Location *	WS
Category	Supplemental			GPS Latitude/Longitude	
				Start	End
Item	DWR UCIP LMA Responsibility			39.174370 °	39.174370 °
				-122.913543 °	-122.913543 °
DWR ID					
Comment Code					
Inspector Comment					
FS_ID:42994 DS_ID:21212 EP_NO: 11483 Repair Type: Non-Urgent Crossing Status: Found UCIP Comments: Pipe appears abandoned and if so, should be done so properly. Debris blocking flapgate at outlet. FIELD_STRUCT_DESC: *ABANDONED* 30-inch CM drainpipe through the levee, 17.8 feet below the crown. Slide gate in 44-inch diameter CMP riser waterward slope. Flap gate on the waterward end at concrete headwall. 6'X8' concrete sump at landward toe. (USACE-1961). Originally included in O&M manual (HLM 1.22). This pipe was retained under ABO No. 11483 (1975). FS Date: 1/22/2014

6'X8' concrete sump filled in with soil, visible at LS toe.

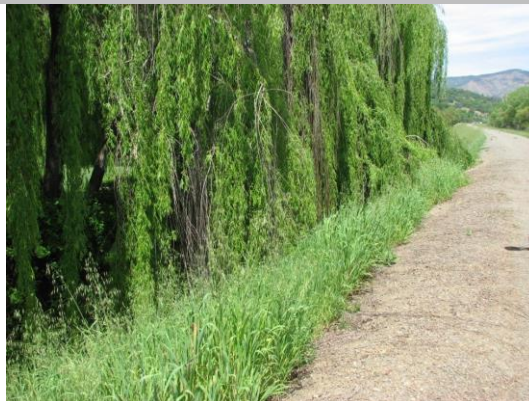
Photo 1 of 1 : SP_2017_NA0009_4_18_20170315_00009.jpg

LM Start	1.92	Rating **	M	Issue No.	18
LM End	1.92	Issue Type +	Ma	Location *	LS
Category	Earthen Levee			GPS Latitude/Longitude	
				Start	End
Item	Trim / Thin Trees			39.163912 °	39.163912 °
				-122.916695 °	-122.916695 °
DWR ID	DWR_NA0009_02_s _ 2016_18				
Comment Code					
T1 : Trim trees to at least five feet above ground level.					
Inspector Comment					
Trim willow trees.

View of the overgrown willow trees at the landside levee slope.

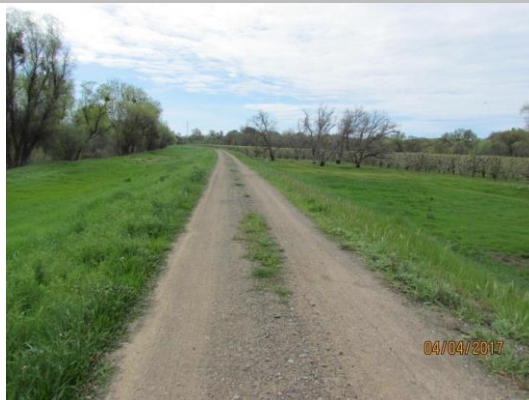
Photo 1 of 1 : SP_2017_NA0009_4_31_20170410_00050.jpg

LM Start	2.70	Rating **	A	Issue No.	31
LM End	2.70	Issue Type +	Ma	Location *	LS
Category	Earthen Levee			GPS Latitude/Longitude	
				Start	End
Item	Vegetation			39.153202 °	39.153202 °
				-122.915672 °	-122.915672 °
DWR ID	DWR_NA0009_02_s _ 2017_31				
Comment Code					
V1 : Control annual grass and weeds on the levee slopes and easements.					
Inspector Comment					
There are native grasses on both slopes.

View of the native grasses on both slopes.

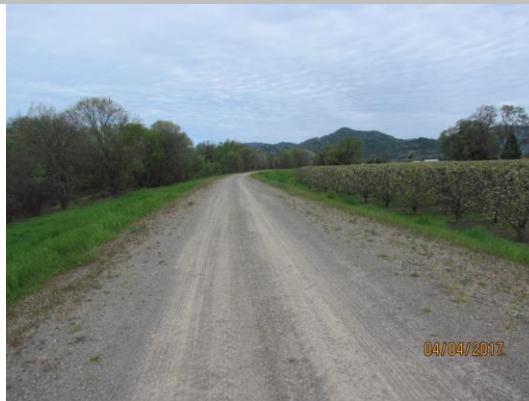
Photo 1 of 1 : SP_2017_NA0009_5_20_20170410_00042.jpg

LM Start	0.24	Rating **	A	Issue No.	20
LM End	0.24	Issue Type +	Ma	Location *	LS
Category	Earthen Levee			GPS Latitude/Longitude	
				Start	End
Item	Vegetation			39.150847 °	39.150847 °
				-122.916367 °	-122.916367 °
DWR ID	DWR_NA0009_03_s _ 2017_20				
Comment Code					
V1 : Control annual grass and weeds on the levee slopes and easements.					
Inspector Comment					
There are native grasses on both slopes.

View of the native grasses on both slopes.

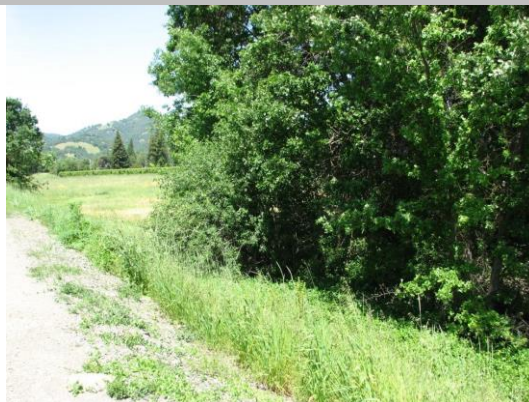
Photo 1 of 1 : SP_2017_NA0009_5_9_20170315_00001.jpg

LM Start	0.49	Rating **	M	Issue No.	9
LM End	0.49	Issue Type +	Ma	Location *	LS
Category	Earthen Levee			GPS Latitude/Longitude	
				Start	End
Item	Vegetation			39.154195 °	39.154195 °
				-122.918134 °	-122.918134 °
DWR ID	DWR_NA0009_03_s _ 2016_9				
Comment Code					
V2 : Remove the wild growth other than native grasses from the levee slopes.					
Inspector Comment

View of the overgrown trees and vegetation at the landside toe.

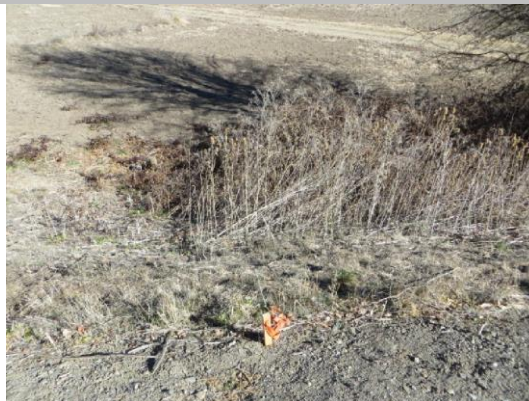
Photo 1 of 3 : UCIP_SP_2017_27863_51542.jpg

LM Start	0.54	Rating **	M	Issue No.	21
LM End	0.54	Issue Type +	Ma	Location *	LS
Category	Supplemental			GPS Latitude/Longitude	
				Start	End
Item	DWR UCIP LMA Responsibility			39.154786 °	39.154786 °
				-122.918703 °	-122.918703 °
DWR ID					
Comment Code					
Inspector Comment					
FS_ID:27863 DS_ID:21217 EP_NO: 11492 Repair Type: Non-Urgent Crossing Status: Found UCIP Comments: Vegetation at inlet and wooden box failing at LS toe. FIELD_STRUCT_DESC: 42-inch CM drainpipe through the levee, 12.0 feet below the crown. Flap gate on the waterward end. Concrete headwalls on both ends with a wooden retaining wall drop inlet at LS toe (USACE-1961). Originally included in O&M manual (HLM 0.55). This pipe was retained under ABO No. 11492 (1975). USACE O&M DWG No. CC-4-4-29. FS Date: 1/22/2014

Pipe visible at LS toe covered with vegetation.

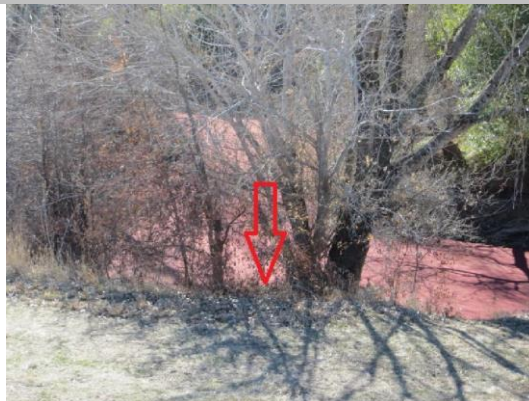
Photo 1 of 3 : UCIP_SP_2017_27894_51599.jpg

FS_ID:27894
DS_ID:21221
EP_NO: 11488
Repair Type: Non-Urgent
Crossing Status: Found
UCIP Comments: Concrete headwall on WS berm is being undermined. 2-foot of scour under headwall.
FIELD_STRUCT_DESC: 42-inch CM drainpipe through the levee, 16.5 feet below the crown. Flap gate on the waterward end. Concrete headwalls on both ends. (USACE-1961). This entry matches the Drainage or Irrigation Structure referenced in O&M manual (HLM 0.94). This pipe was retained under ABO No. 11488 (1975).
FS Date: 1/22/2014

Flapgate and headwall off WS toe.

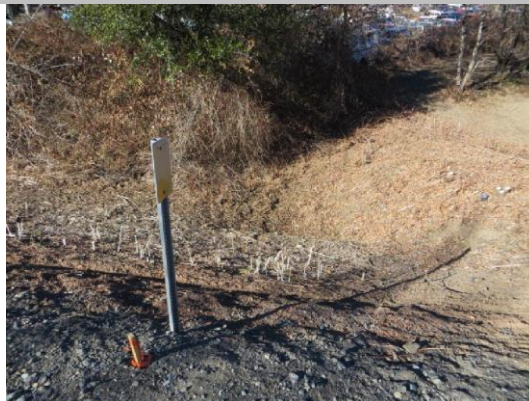
Photo 1 of 3 : UCIP_SP_2017_27944_51646.jpg

LM Start	1.07	Rating **	M	Issue No.	28
LM End	1.07	Issue Type +	Ma	Location *	WS
Category	Supplemental			GPS Latitude/Longitude	
				Start	End
Item	DWR UCIP LMA Responsibility			39.159803 °	39.159803 °
				-122.923501 °	-122.923501 °
DWR ID					
Comment Code					
Inspector Comment					
FS_ID:27944					
DS_ID:21223					
EP_NO: 11489					
Repair Type: Non-Urgent					
Crossing Status: Found					
UCIP Comments: Some sedimentation buildup at inlet and through pipe.					
FIELD_STRUCT_DESC: 24-inch CM drainpipe through the levee, 12.5 feet below the crown. Flap gate on the waterward end. Concrete headwalls on both ends. (USACE-1961). This entry matches the Drainage or Irrigation Structure referenced in O&M manual (HLM 1.09). This pipe was retained under ABO No. 11489 (1975).					
FS Date: 1/22/2014

Flasher on crown marks pipe location.

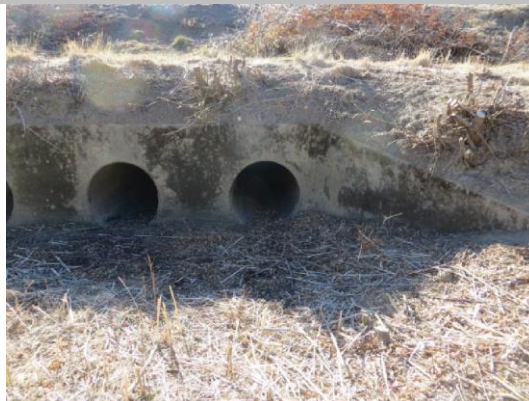
Photo 1 of 3 : UCIP_SP_2017_27967_51671.jpg

LM Start	1.24	Rating **	A/W	Issue No.	32
LM End	1.24	Issue Type +	Ma	Location *	WS
Category	Supplemental			GPS Latitude/Longitude	
				Start	End
Item	DWR UCIP LMA Responsibility			39.160386 °	39.160386 °
				-122.926239 °	-122.926239 °
DWR ID					
Comment Code					
Inspector Comment					
FS_ID:27967					
DS_ID:21239					
EP_NO: 11489					
Repair Type: No Action Needed					
Crossing Status: Found					
UCIP Comments:					
FIELD_STRUCT_DESC: 4 of 4: 36-inch CM drainpipe through the					
levee, 15.2 feet below the crown. Flap gate on the waterward end.					
Concrete headwalls on both ends. (USACE-1961). This entry matches					
the Drainage or Irrigation Structure referenced in O&M manual (HLM					
1.25). This pipe was retained under ABO No. 11489 (1975).					
FS Date: 1/22/2014

Pipe and concrete headwall on LS toe.

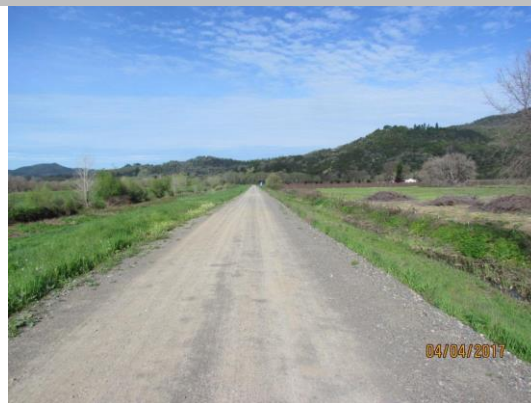
Photo 1 of 1 : SP_2017_NA0009_6_15_20170410_00021.jpg

LM Start	0.40	Rating **	A	Issue No.	15
LM End	0.40	Issue Type +	Ma	Location *	LS
Category	Earthen Levee			GPS Latitude/Longitude	
				Start	End
Item	Vegetation			39.176400 °	39.176400 °
				-122.905020 °	-122.905020 °
DWR ID	DWR_NA0009_04_s_2017_15				
Comment Code					
V1 : Control annual grass and weeds on the levee slopes and easements.					
Inspector Comment					
There are native grasses on both slopes.

View of the native grasses on both slopes.

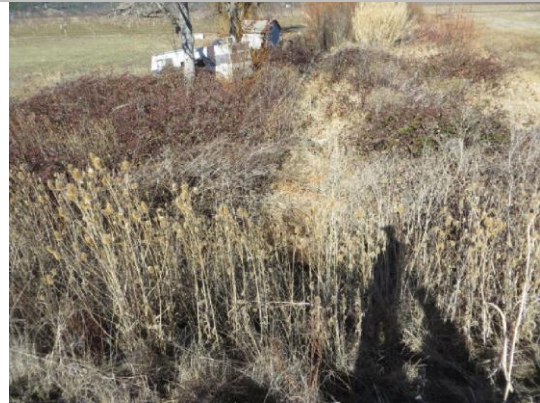
Photo 1 of 3 : UCIP_SP_2017_51472_49754.jpg

Drainage canal at inlet on LS toe.

Comment Code						
Inspector Comment						
FS_ID:51472 DS_ID:21227 EP_NO: 11501 Repair Type: Urgent Crossing Status: Found UCIP Comments: 11/30/2016 Clover Creek has significant sediment build up that blocks the outlet. Crossing is still in use to drain water from LS to WS according to LMA representative, Scott Webb. (O. Magana - DWR UCIP)01/09/2014 Pipe rusted through at connection to flapgate. Good indication pipe may need replacement. Video inspection recommended. (W. Wylie - DWR UCIP) FIELD_STRUCT_DESC: 24-inch corrugated metal (CM) drainage pipe through the levee, 13.8 feet below the crown. Flap gate is located on the waterside (WS) end. Concrete headwalls located on both the WS and landside (LS) ends. (24-inch pipe was retained under Automatic Board Order (ABO) issued as Permit No. 11501, 1975 - Sisevich). [Additional Reference(s): DWR Levee Log, 2005. USACE Sacramento O&M Manual Unit 506.2, August 1961, (HLM 0.77)]. FS Date: 11/30/2016

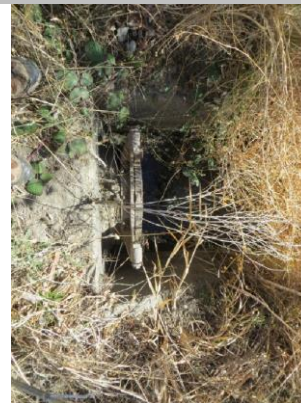
Photo 3 of 3 : UCIP_SP_2017_51472_49752.jpg

Flapgate at concrete headwall on WS toe.

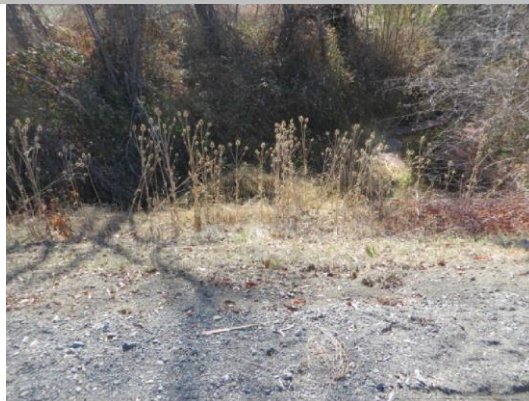
Photo 2 of 3 : UCIP_SP_2017_26888_49665.jpg

LM Start	0.32	Rating **	M	Issue No.	16 (cont)	
LM End	0.32	Issue Type +	Ma	Location *	LS	
Category	Supplemental			GPS Latitude/Longitude		
				Start	End	
Item	DWR UCIP LMA Responsibility			39.177078 °	39.177078 °	
				-122.898926 °	-122.898926 °	
DWR ID						
Comment Code						
Inspector Comment						
FS_ID:26888						
DS_ID:21233						
EP_NO: 11507						
Repair Type: Non-Urgent						
Crossing Status: Found						
UCIP Comments: Some sediment buildup at outlet on LS toe.						
FIELD_STRUCT_DESC: 3 of 6: 36-inch CM irrigation pipe through the						
levee, 12.0 feet below the crown. Concrete headwall on both ends.						
Steel slide gate plate blocks inlet on WS toe. Originally included in						
1961 O+M manual. Structure and pipes retained under ABO Permit No.						
11507 (1975).						
FS Date: 1/9/2014

Outlet visible at concrete headwall on LS toe.

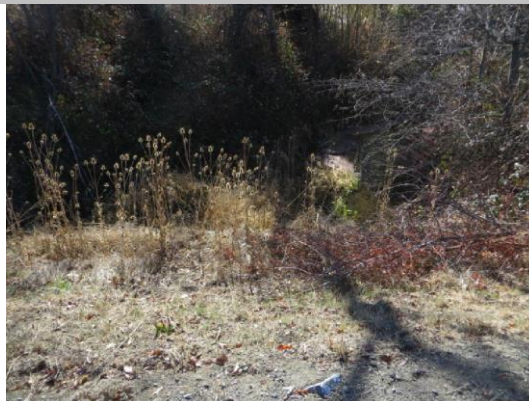
Photo 2 of 3 : UCIP_SP_2017_26883_49621.jpg

LM Start	0.32	Rating **	M	Issue No.	18 (cont)	
LM End	0.32	Issue Type +	Ma	Location *	LS	
Category	Supplemental			GPS Latitude/Longitude		
				Start	End	
Item	DWR UCIP LMA Responsibility			39.177070 °	39.177070 °	
				-122.898967 °	-122.898967 °	
DWR ID						
Comment Code						
Inspector Comment						
FS_ID:26883						
DS_ID:21231						
EP_NO: 11507						
Repair Type: Non-Urgent						
Crossing Status: Found						
UCIP Comments: Some sediment buildup on LS toe.						
FIELD_STRUCT_DESC: 5 of 6: 36-inch CM irrigation pipe through the						
levee, 12.0 feet below the crown. Concrete headwall on both ends						
[Clover Creek Diversion Structure] . Steel slide gate blocks inlet on WS						
toe. Originally included in 1961 O+M manual. Structure and pipes						
retained under ABO Permit No. 11507 (1975).						
FS Date: 1/9/2014

Pipe visible at concrete headwall on LS toe.

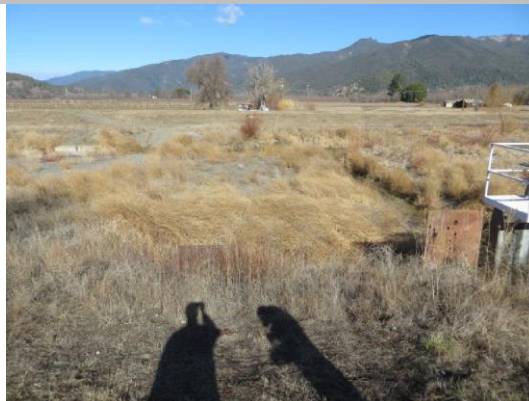
Photo 1 of 3 : UCIP_SP_2017_26877_49610.jpg

LM Start	0.32	Rating **	M	Issue No.	19
LM End	0.32	Issue Type +	Ma	Location *	LS
Category	Supplemental			GPS Latitude/Longitude	
				Start	End
Item	DWR UCIP LMA Responsibility			39.177066 °	39.177066 °
				-122.898986 °	-122.898986 °
DWR ID					
Comment Code					
Inspector Comment					
FS_ID:26877					
DS_ID:21229					
EP_NO: 11507					
Repair Type: Non-Urgent					
Crossing Status: Found					
UCIP Comments: Some sediment buildup at outlet on LS toe.					
FIELD_STRUCT_DESC: 6 of 6: 36-inch CM pipe through the levee,					
12.0 feet below the crown [Clover Creek Diversion Structure]. Concrete					
headwall on both ends. Steel slide gate covers WS inlet. Structure and					
pipes retained under ABO Permit No. 11507 (1975). Originally included					
in 1961 O+M manual.					
FS Date: 1/9/2014

Steel slide gate visible at headwall on WS toe.
